Fractographic Inspection of the
Cracking FT488/2 Removed at
Program 79

DSTO-TN-0170

**Airframes and Engines Division
Aeronautical and Maritime Research Laboratory**

During the inspection of the FT488/2 Bare Bulkhead Fatigue Test specimen after 79 blocks of applied loading, cracking was found in several wing-attachment hole aft edges. Each of the cracked regions of the holes was cut from the bulkhead, sixteen of the cracks were broken open and the exposed crack surfaces were analysed. This analysis revealed several interesting aspects of fatigue crack growth in this bulkhead. These included the nature of the most (in this case) significant initiating flaws, the type (compared to other thick 7050 plate material) and effect of the microstructure on the growth of these cracks, and the relative growth rates of these cracks including estimates of the number of programs to failure.

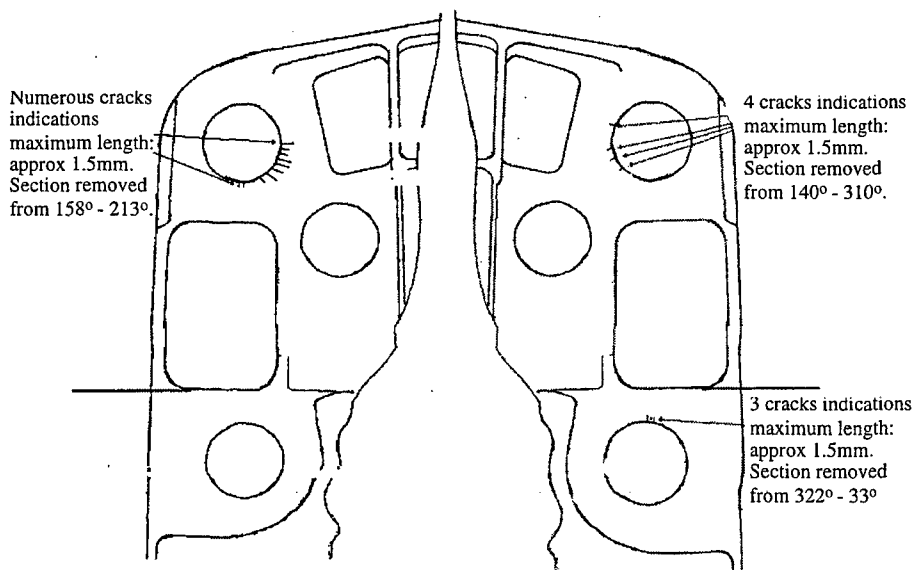
The NDE examinations indicated cracking up to 1.5mm along the aft face of the bulkhead and 1mm down the bore of the wing-attachment holes. The positions of these cracks, as indicated in NDI report B38/97, are shown in Figures 1 & 2.

Figure 1. The position of the cracking found in the wing-attachment hole aft edges. Also, note the extent of the region removed is marked.

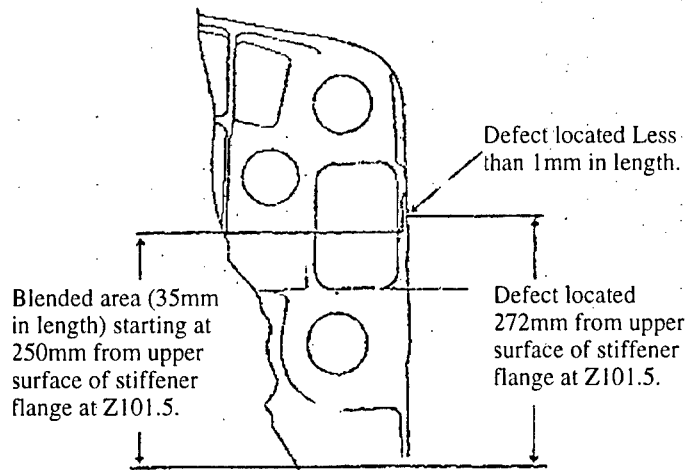
Figure 2 The position of the crack indication found in the 4" radius

The sliver removed from the port forward 4" radius was inspected and loaded in three point bending to reveal any cracks present. No cracking was observed, rather, a defect in the IVD coating at about the position of the suspected crack was found and probably accounts for the NDI indication.

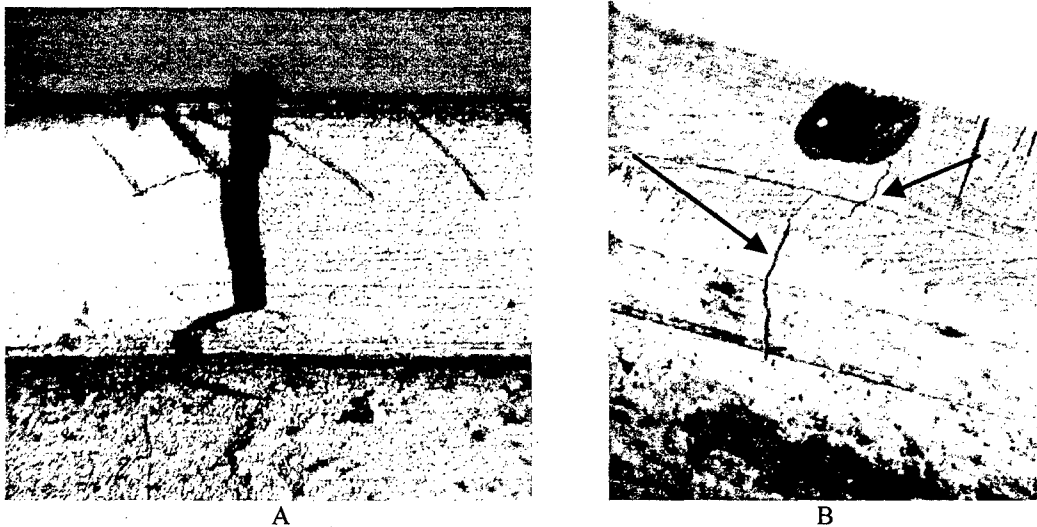
All of the sections removed from the wing-attachment holes aft edges were found to contain cracks. An example is shown in Figure 2A, which has been partially opened (note that the jagged part of this crack is the result of the opening). On stressing the starboard upper section revealed 7 crack locations, the starboard lower section 3 crack locations and the port upper section 11 crack locations. Several of these crack locations had two closely associated cracks, as shown in Figure 2B. Schematic diagrams of the approximate positions of the observed cracks and the material removed, are shown in Figure 3.

Figure 2. Examples of two of the cracks revealed in the section removed from the port wing-attachment hole upper aft edge. Both of these views were taken with the cracking loaded. View 'A' shows a ridge on the hole surface – the fatigue part of the crack is the vertical part, that which follows is tearing due to the applied opening load. In 'B' the corner is roughly in the middle of the field with the hole-surface on the lower side and the aft face of the bulkhead on the upper side. Note that two cracks exist in this location, the second independent of the hole surface or edge.

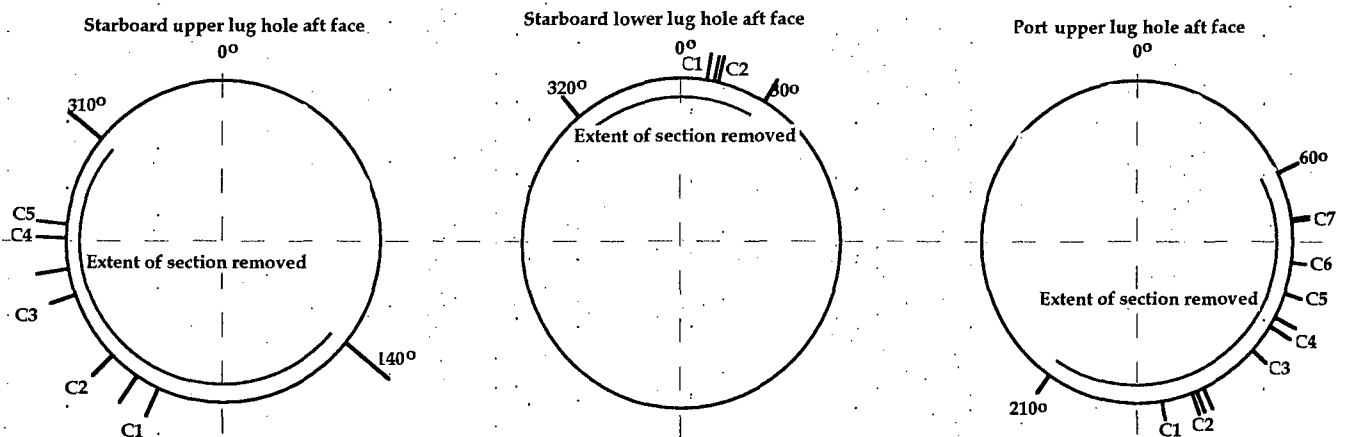
Figure 3. A schematic diagram of the approximate positions of the observed cracks in the edge of the wing-attachment holes. The red line indicates the region of material removal. The cracks that were opened and examined by fractography are marked 'C1, C2, etc'.

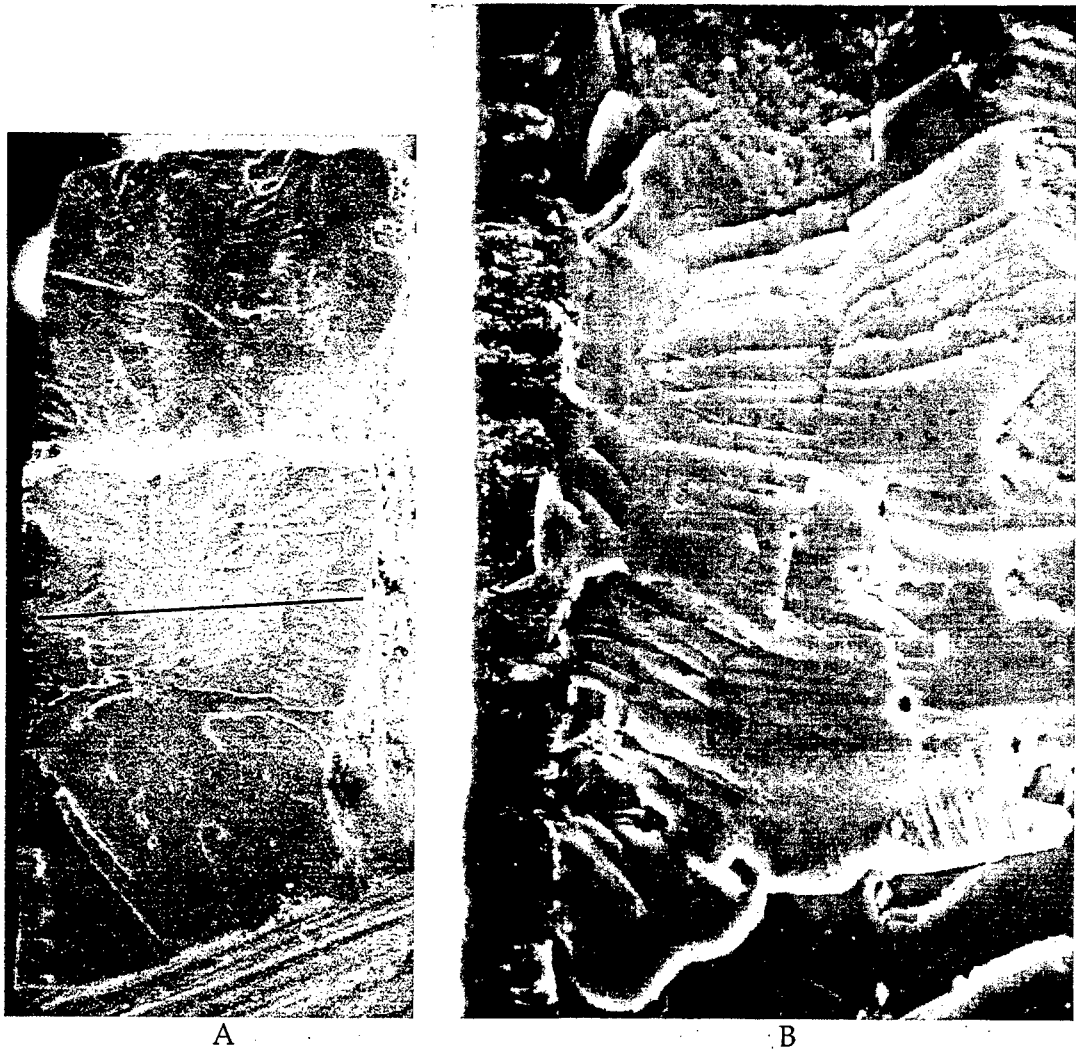
This crack originated from multiple sites beneath the intact IVD (Ion Vapour Deposited aluminium) coating on the aft face of the bulkhead, Figure 7. The IVD appears as a dark layer of columnar grains at the left of view B Figure 7. Two main areas of initiation resulted in two similarly sized cracks, view A Figure 7. It appears that small grain boundary penetrations, probably caused by etching during the application of the IVD coating, acted as the initiating flaws, Figure 7 view B. The cracks grew as a series of 'thumbnail' shaped cracks, which linked to form a broad crack front for both major cracks. These cracks were growing forward into the bulkhead. Intersection with the wing-attachment hole probably occurred when the crack had reached a depth of about 100µm. At that time the crack closest to the hole was probably independent of the second crack, which had initiated further from the hole

Figure 7. Views of the profile of crack 2 and the initiation area. The line shown in view A designates the approximate line followed during fractography. The cracking initiated beneath the IVD on the aft surface of the bulkhead. The cracking originated at surface etching rather than any other more pronounced flaw

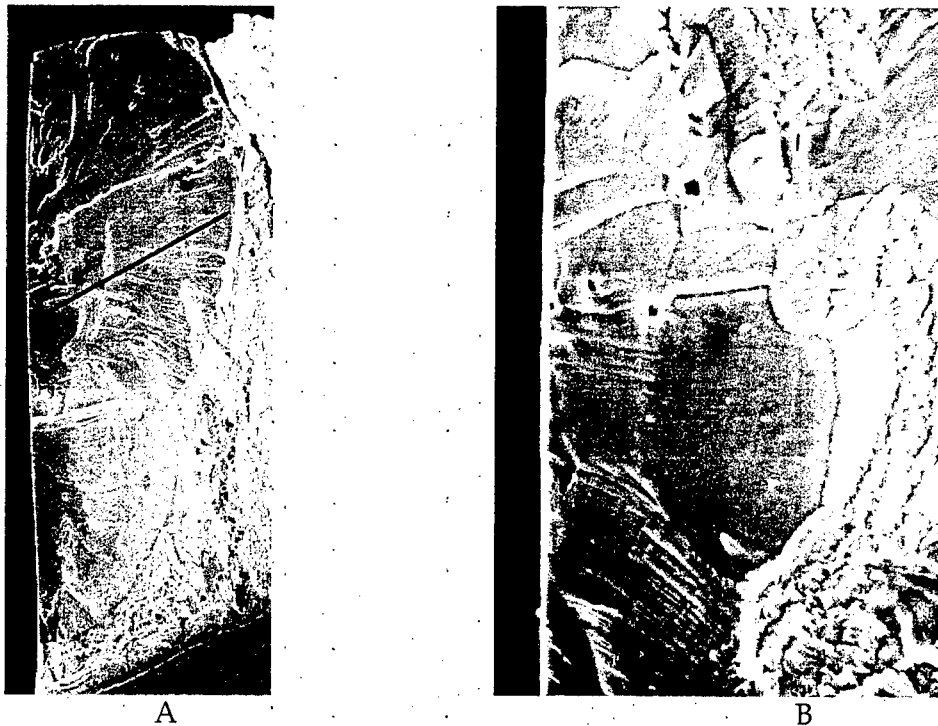
In this case, the main crack origin occurred some distance from the wing-attachment-hole. The crack grew with a 'thumbnail' shape and remained independent of the wing-attachment hole for a large part of its life. The actual originating flaw had been removed by polishing during the test. The crack is shown in Figure 11A, while view B shows a close up of the region from which the fractography measurements were started.

Figure 11. Views of the crack profile and initiation area, showing, in view A, the approximate line followed during fractography.

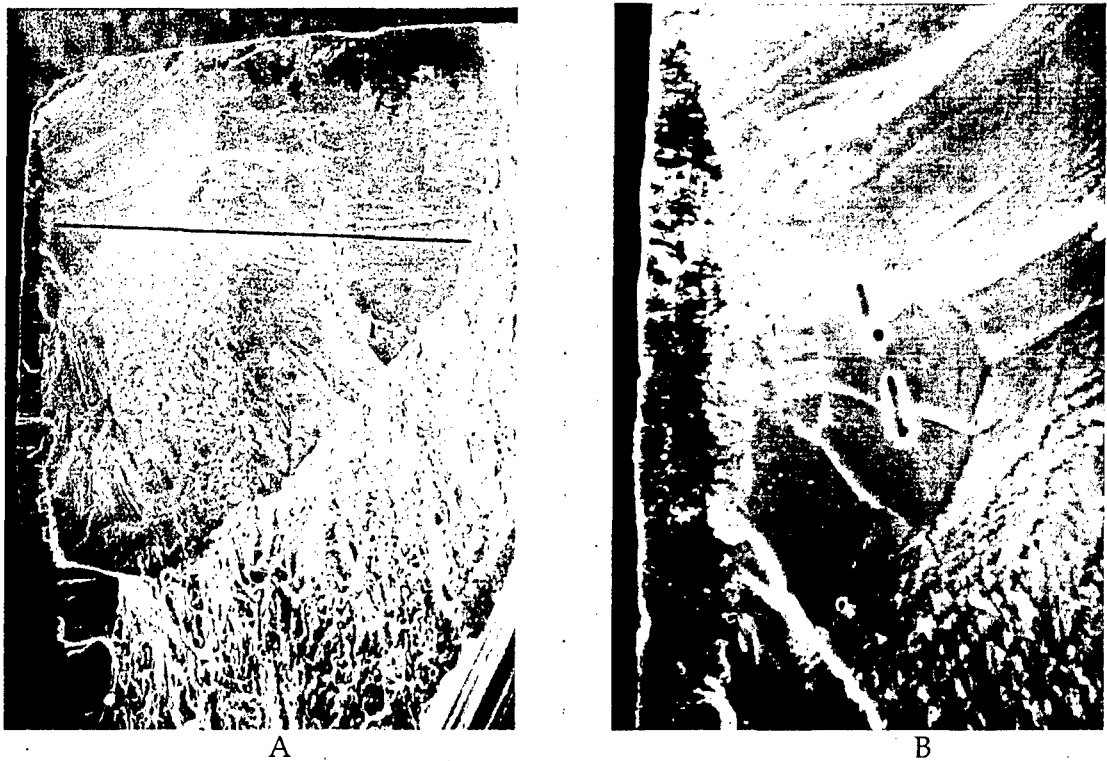
This crack, originated from multiple sites beneath the intact IVD coating on the aft face of the bulkhead, Figure 13A. Again small etch-pits, probably associated with grain boundaries, acted as the initiating flaws, with the initial crack growing along a grain boundary, Figure 13B. Intersection with the wing-attachment hole probably occurred at a crack depth of about 50µm.

Figure 13. 'A' shows the crack profile and the line indicating the approximate path followed during fractography. View B shows the initiation site. Note some porosity in the middle of view B, which had no apparent effect on the crack growth.

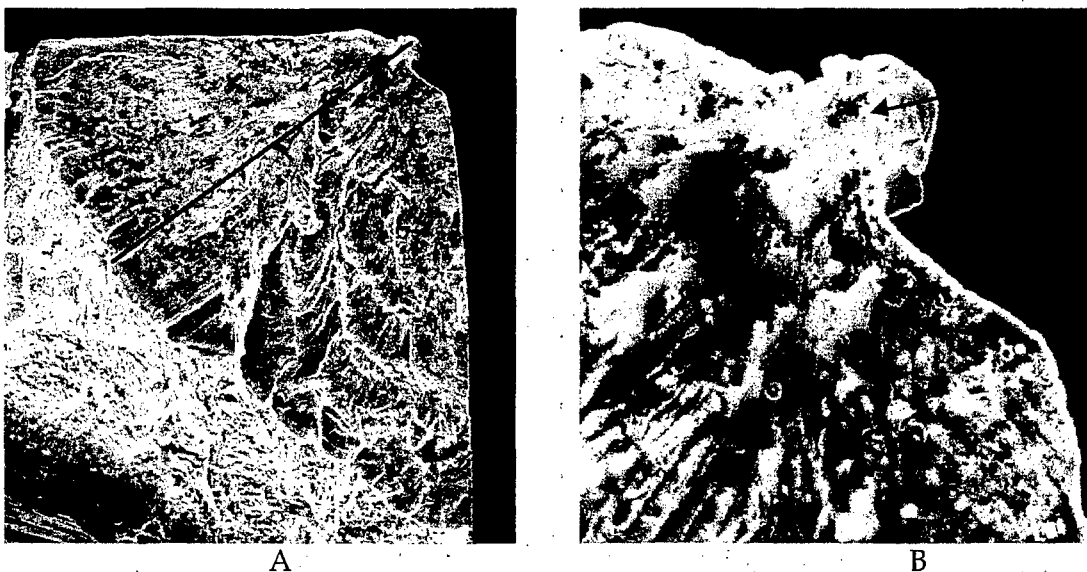
This crack initiated from a lip formed through mechanical damage to the edge of the hole. The crack appeared to have grown very quickly through the lip before commencing slow growth in to the bulk of the bulkhead. No microstructural detail could be discerned as aiding in the initiation of this crack. For the majority of its life, the crack grew as a corner crack. Figure 15A shows the entire crack and 15B a close up of the lip. Figure 16 shows the crack and the damage to the edge of the hole. It can be seen that the damage was caused by something producing a groove in the edge of the hole, possibly the wing- attachment pin or the alignment device. Figure 16 also shows the step in the bore of the hole, which was made by the copper alloy bush during cold expansion.

Figure 15. The crack profile and the initiation area of crack 1. Note that the initiation is associated with a lip caused by damage to the edge of the hole. The line shown in view A designates the approximate line followed during fractography. Cracking initiated in the lip (arrow).

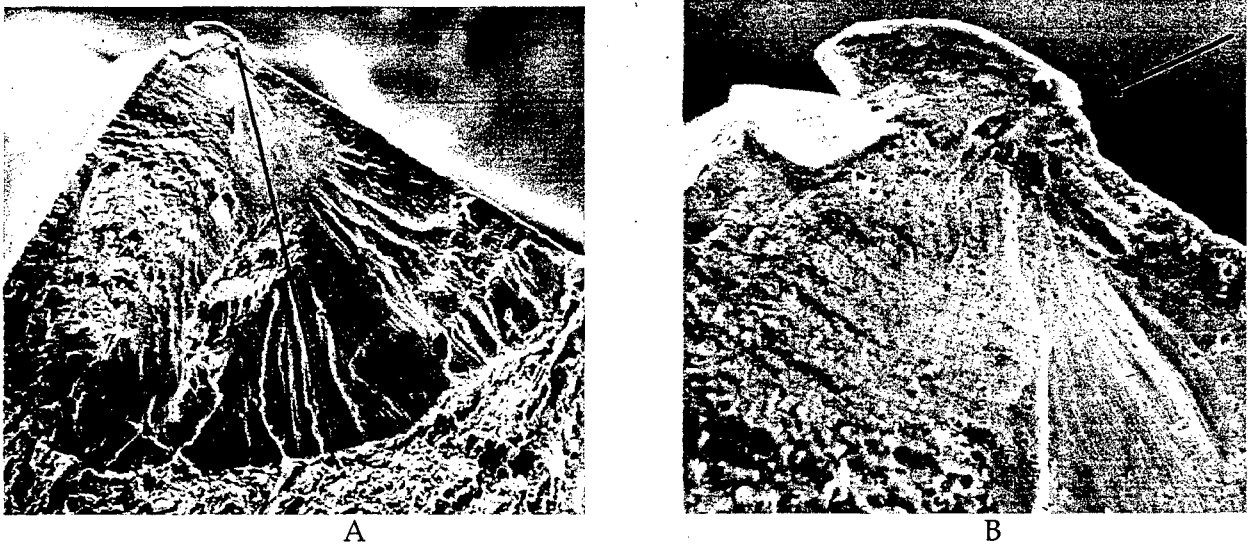
This crack also initiated from the starboard lower wing-attachment hole at the back of a lip formed by damage to the edge of the hole. Again, no microstructural detail could be seen to have affected the initiation of this crack. The crack grew for the majority of its life as a corner crack. The entire crack is shown in Figure 18A, a close up of the initiation region is shown in 'B'.

Figure 18. The crack profile and initiation area of the second crack in the starboard lower aft wing-attachment wing-attachment-hole edge. Note that the initiation is associated with a lip caused by damage to the edge of the hole. The line shown in view A designates the approximate line followed during fractography. Cracking initiated on the hole bore surface at the back of the lip (arrow).

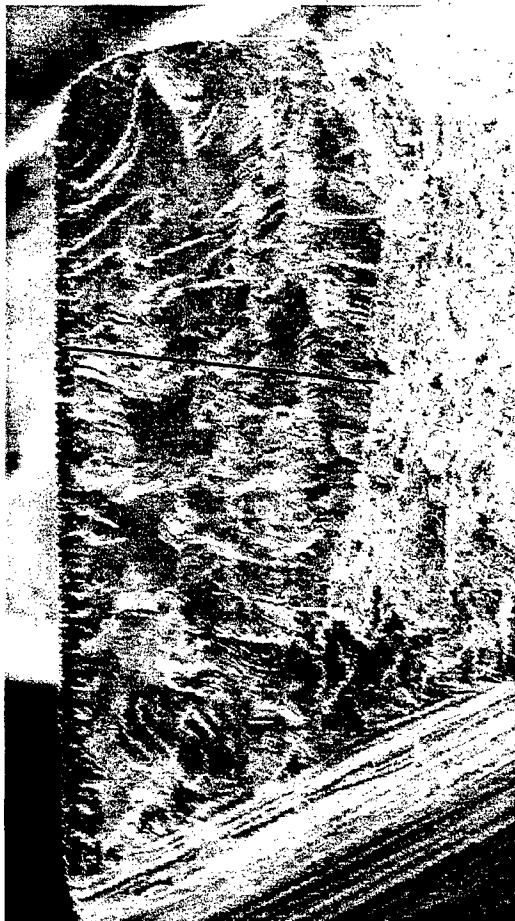
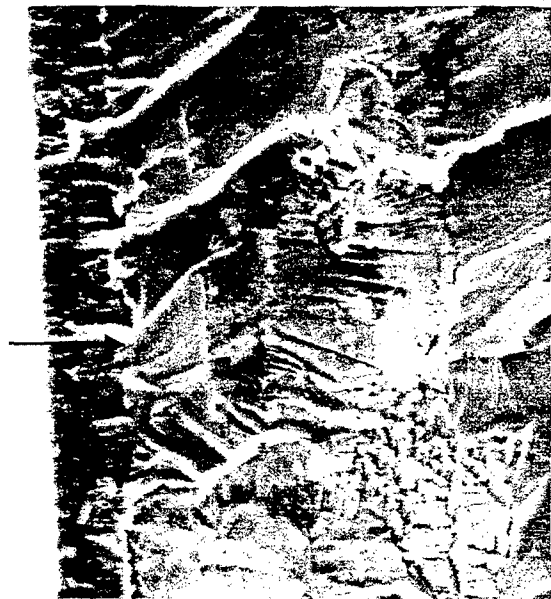
This crack originated from multiple sites beneath the intact IVD coating on the aft face of the bulkhead. These sites were spread over about a 0.5mm length centred about 0.5mm from the hole edge. The numerous cracks joined to form a single crack front, Figure 21A. Small etch-pits, probably associated with grain boundaries, acted as the initiating flaws. Intersection with the wing-attachment hole probably occurred relatively late in the crack growth life - at a crack depth of about 200µm.

Figure 21. The line shown in view A designates the approximate line followed during fractography. The cracking initiated beneath the IVD at the surface of the 7050. The initiation site used in the fractography is marked with an arrow.

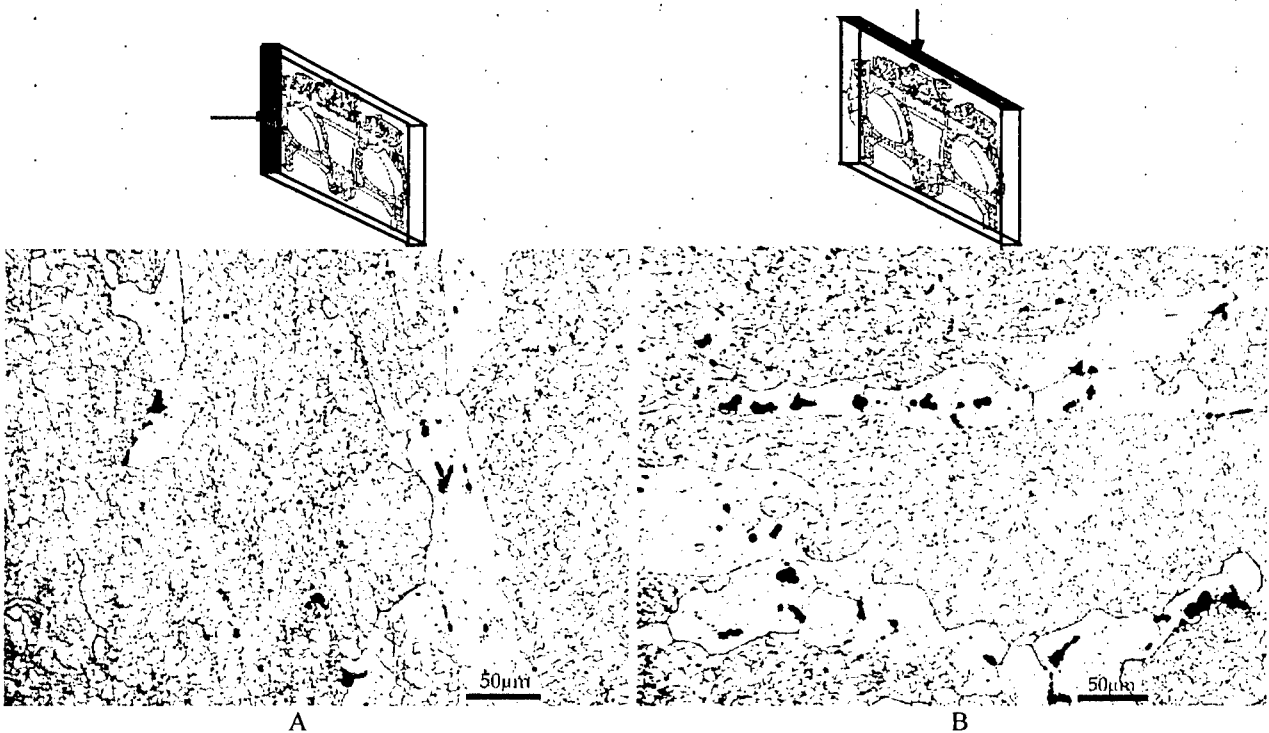
Figure 34 The general microstructure of two sections through the port upper aft sliver. Note that these sections show the duplex grain size and the massive inclusions associated with the large grains.

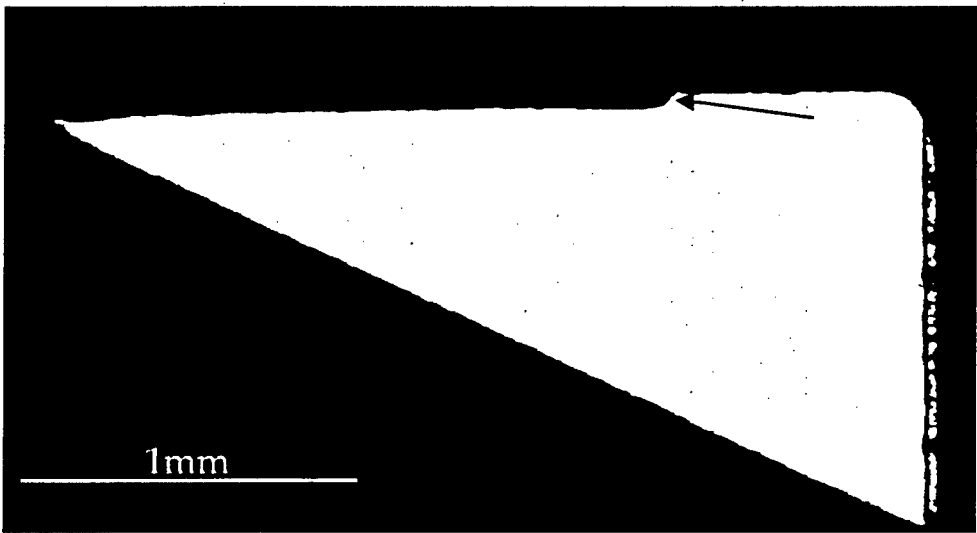
Figure 35 Section through the piece removed from the edge of the port upper aft hole revealed the extent of the step (arrow) caused by the copper alloy bush in the hole.

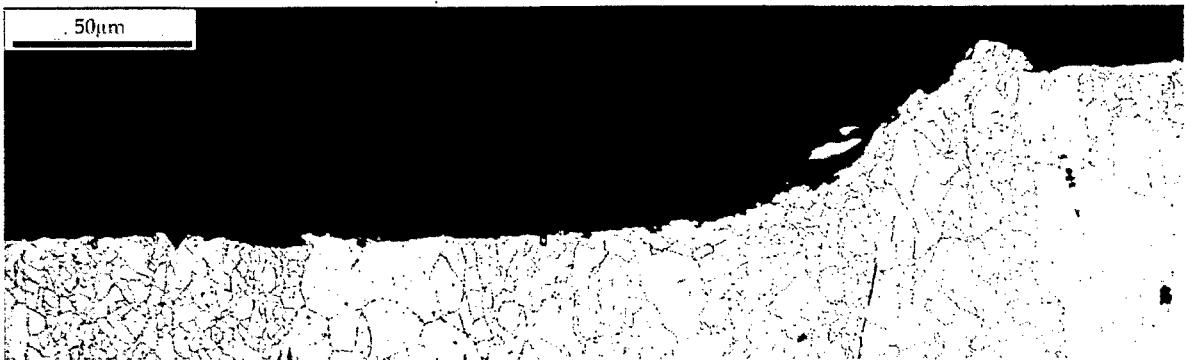
Figure 36 Close view of the piece shown in Figure 35 showing the 7050 aluminium alloy etched. Distortion of the grains at the step can be seen, while no distortion of the grains can be seen in the area that was under the bush.

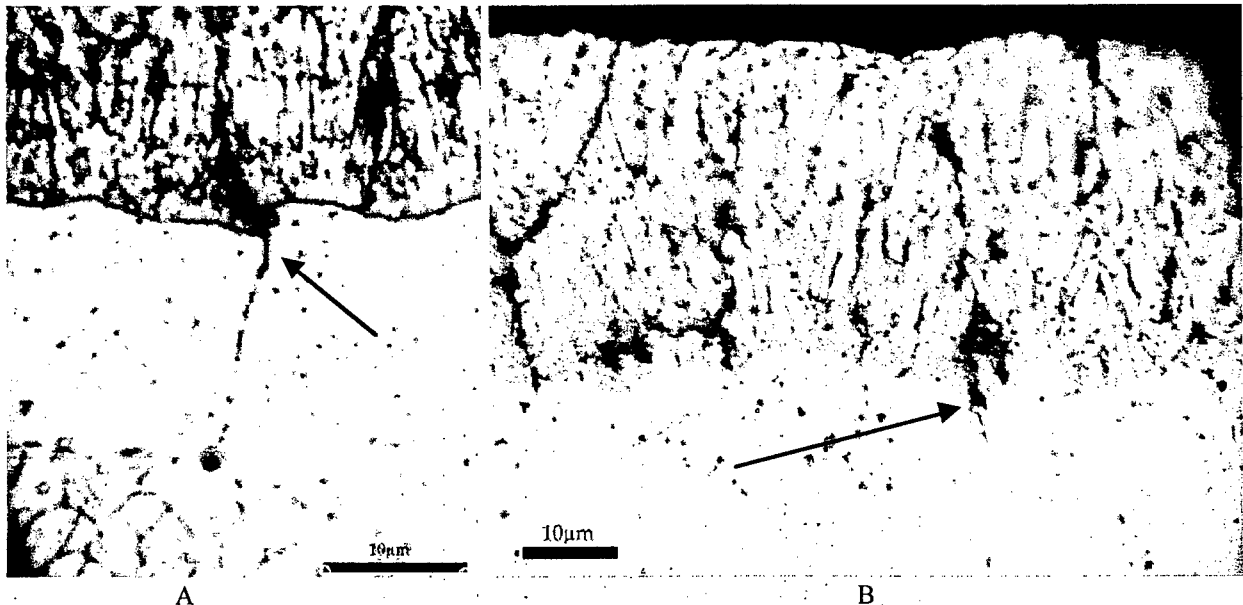
Figure 37 Penetrations produced at the grain boundaries (arrows) of the 7050, beneath the IVD layer can be seen in both these sections. The IVD appears as a porous columnar layer over the 7050. Note view A is etched with Keller's Reagent, View B is unetched.

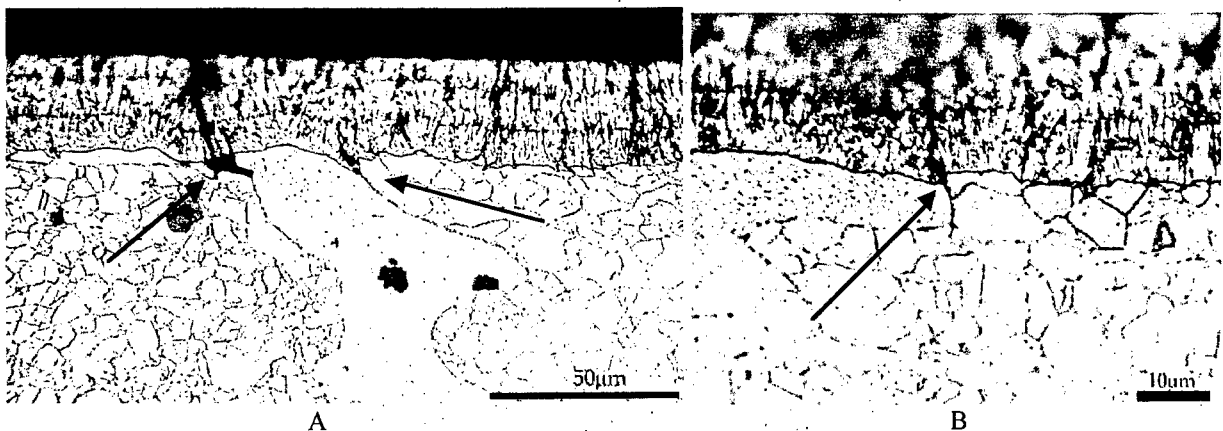
Figure 38 More examples of penetrations produced at the grain boundaries (arrows) of the 7050, beneath the IVD layer. Note both views are etched with Keller's Reagent.

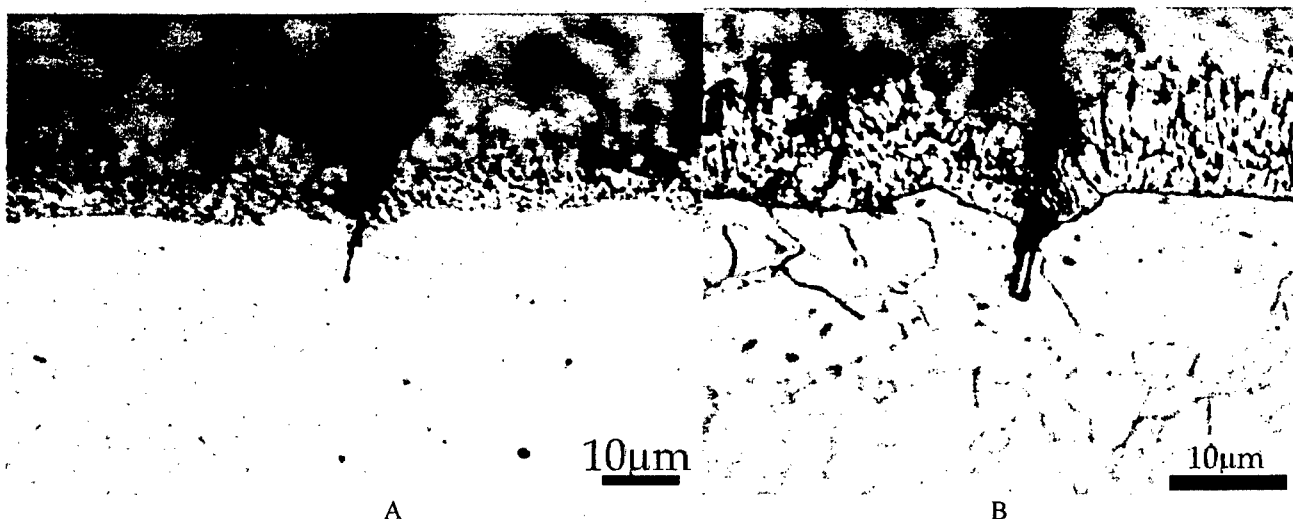
Figure 39. Two views of the same defect in the unetched and etched condition showing a small crack-like defect, clearly growing from a surface etch pit, beneath the IVD coating. This etch pit was also clearly associated with a grain boundary. Note view B is etched with Keller's Reagent.

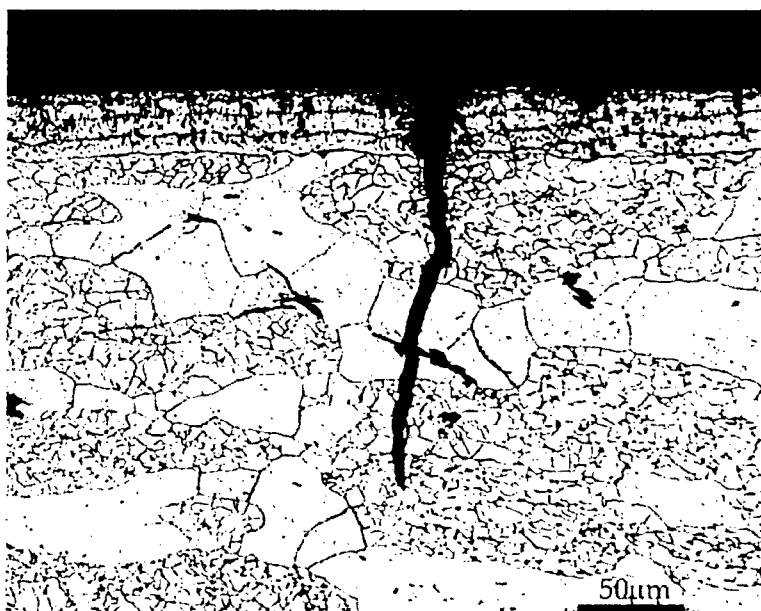
Figure 40. One of the smaller fatigue cracks found during sectioning of a piece (between crack 3 and 4) of the port upper aft wing-attachment hole edge. The crack is gaping due to loading during the breaking open of other cracks. Note that where the crack grows through the large grain the crack path is very straight.

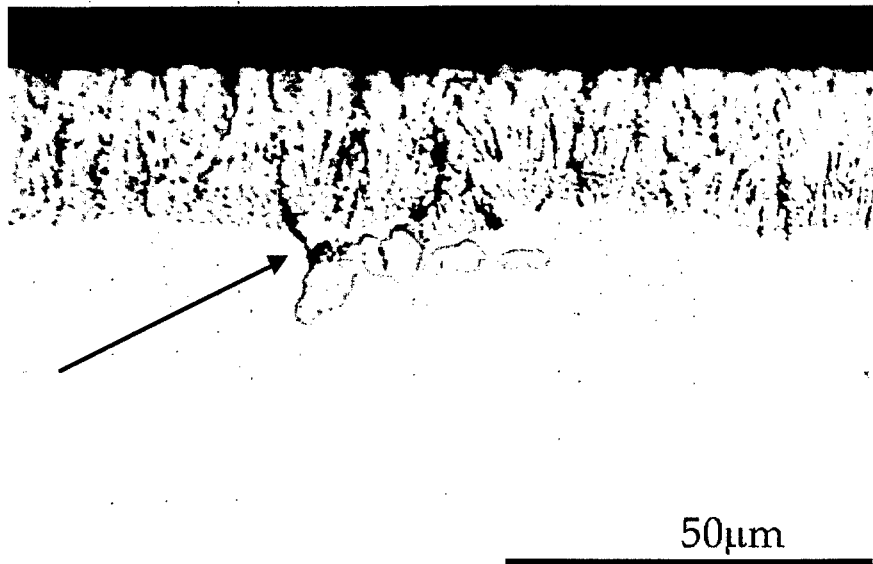
Figur 40. One of the very small fatigue cracks found during sectioning of a piece (between crack 3 and 4) of the port upper aft wing-attachment hole edge. The crack (arrow) appears to have arrested when it meet an inclusion. Note also that there appears to be a crack in one of the inclusion that has not propagated a fatigue crack. (second inclusion from the left)
